16th Avenue Trunk Sewer  
Environmental Management Plan  
Incident Report Form

**SITE VISIT**

**Date:** November 11, 2004  
**Location:** 3855 Bethesda Side Road  
**Time:** 2:30 PM  
**MacViro Field Staff:** John Chadwick, Heather McGinnity  
**Other Representatives:** Renato Pasqualine (Inspec-Sol/CRA)

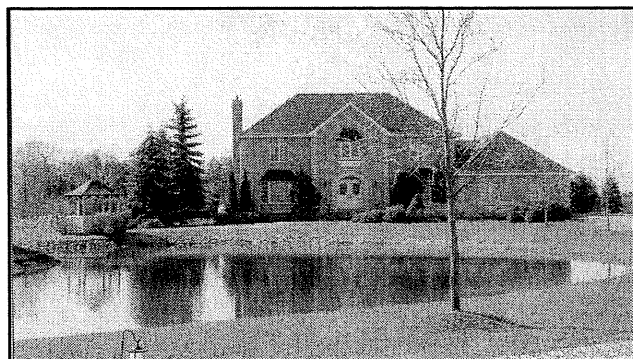
**Photo 1**

View of northern pond in prior to water loss

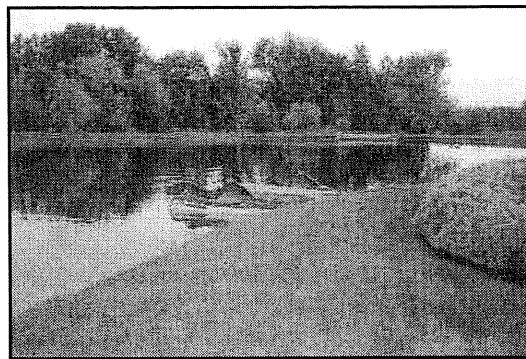
**Photo 2**

View of southern pond in prior to water loss

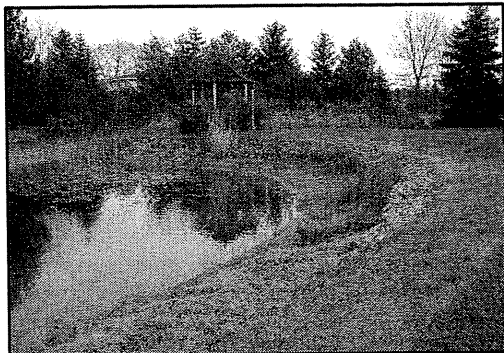
Photo 3

There are two pond areas on the property - one in front of the house (north) and one behind the house (south). These ponds used to be connected along the east side of the house. Both ponds were originally supported by an artesian well on the property, which also served as the potable water supply for the residence. Overflow from the ponds was directed to the drainage ditch along the south side of Bethesda Side Rd. According to Mr. Doug Pike, the artesian conditions ceased to exist in the well about a year and a half ago (Summer 2003). The northern pond perimeter was measured as 130 m originally (based on bank level); the current northern pond perimeter is measured as 112 m (based on water level). A survey of the water levels and the bank levels suggest that the water has dropped up to 0.75 m in the northern pond, and up to 0.88 m in the southern pond. According to Mr. Pike, the original depths of the north and south ponds were approximately 12 and 17 ft respectively.

View of northern pond on November 11, 2004

- The source of the water being discharged to the drainage ditch on the north side of Bethesda Side Road
- The change in water levels in the ponds and well over the next few months

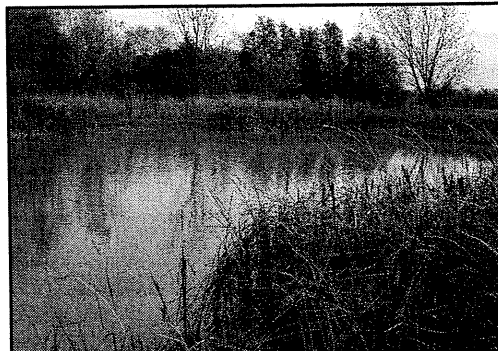
Photo 4

Bull rushes, willows, and algae have been reported to grow in the pond since the well stopped flowing. Several coy (fish) that were stocked in the pond by Mr. Pike died in the spring. He collected a sample of the pond water and submitted it for analysis. It was determined that the dissolved oxygen concentration in the water was extremely low due to the increased vegetative growth. It is believed that the dissolved oxygen deficit caused the fish to die.

View of southern pond on November 11, 2004

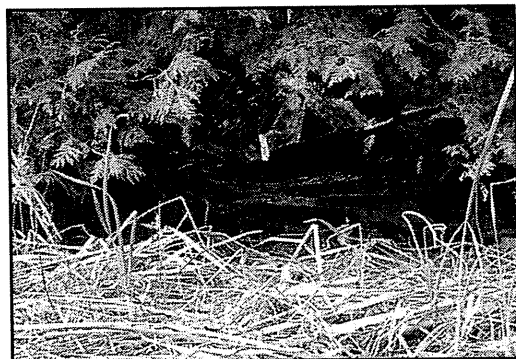
Photo 5

During the site visit, MacViro field staff became aware of water being discharged to the drainage ditch on the north side of Bethesda Side Road. It appeared to be coming from the property directly across the street from Mr. Pike (3880 Bethesda Side Road). The drainage ditch on the north side of Bethesda had water pooling in it and aquatic vegetation, while the drainage ditch on the south side of Bethesda was completely dry. At this point, it is unclear where the water is coming from. It is recommended that further investigations be conducted to determine the source.

View of water discharging to drainage ditch on the north side of Bethesda Side Road

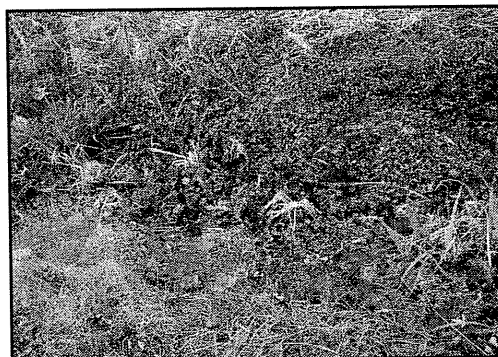
Photo 6

View of vegetation in drainage ditch on the north side of Bethesda Side Road
