# **DEWATERING COMPLAINT REVIEW COMMITTEE**

Wednesday, April 9, 2008

# **16<sup>th</sup> Avenue Dewatering – Aquifer Recovery**

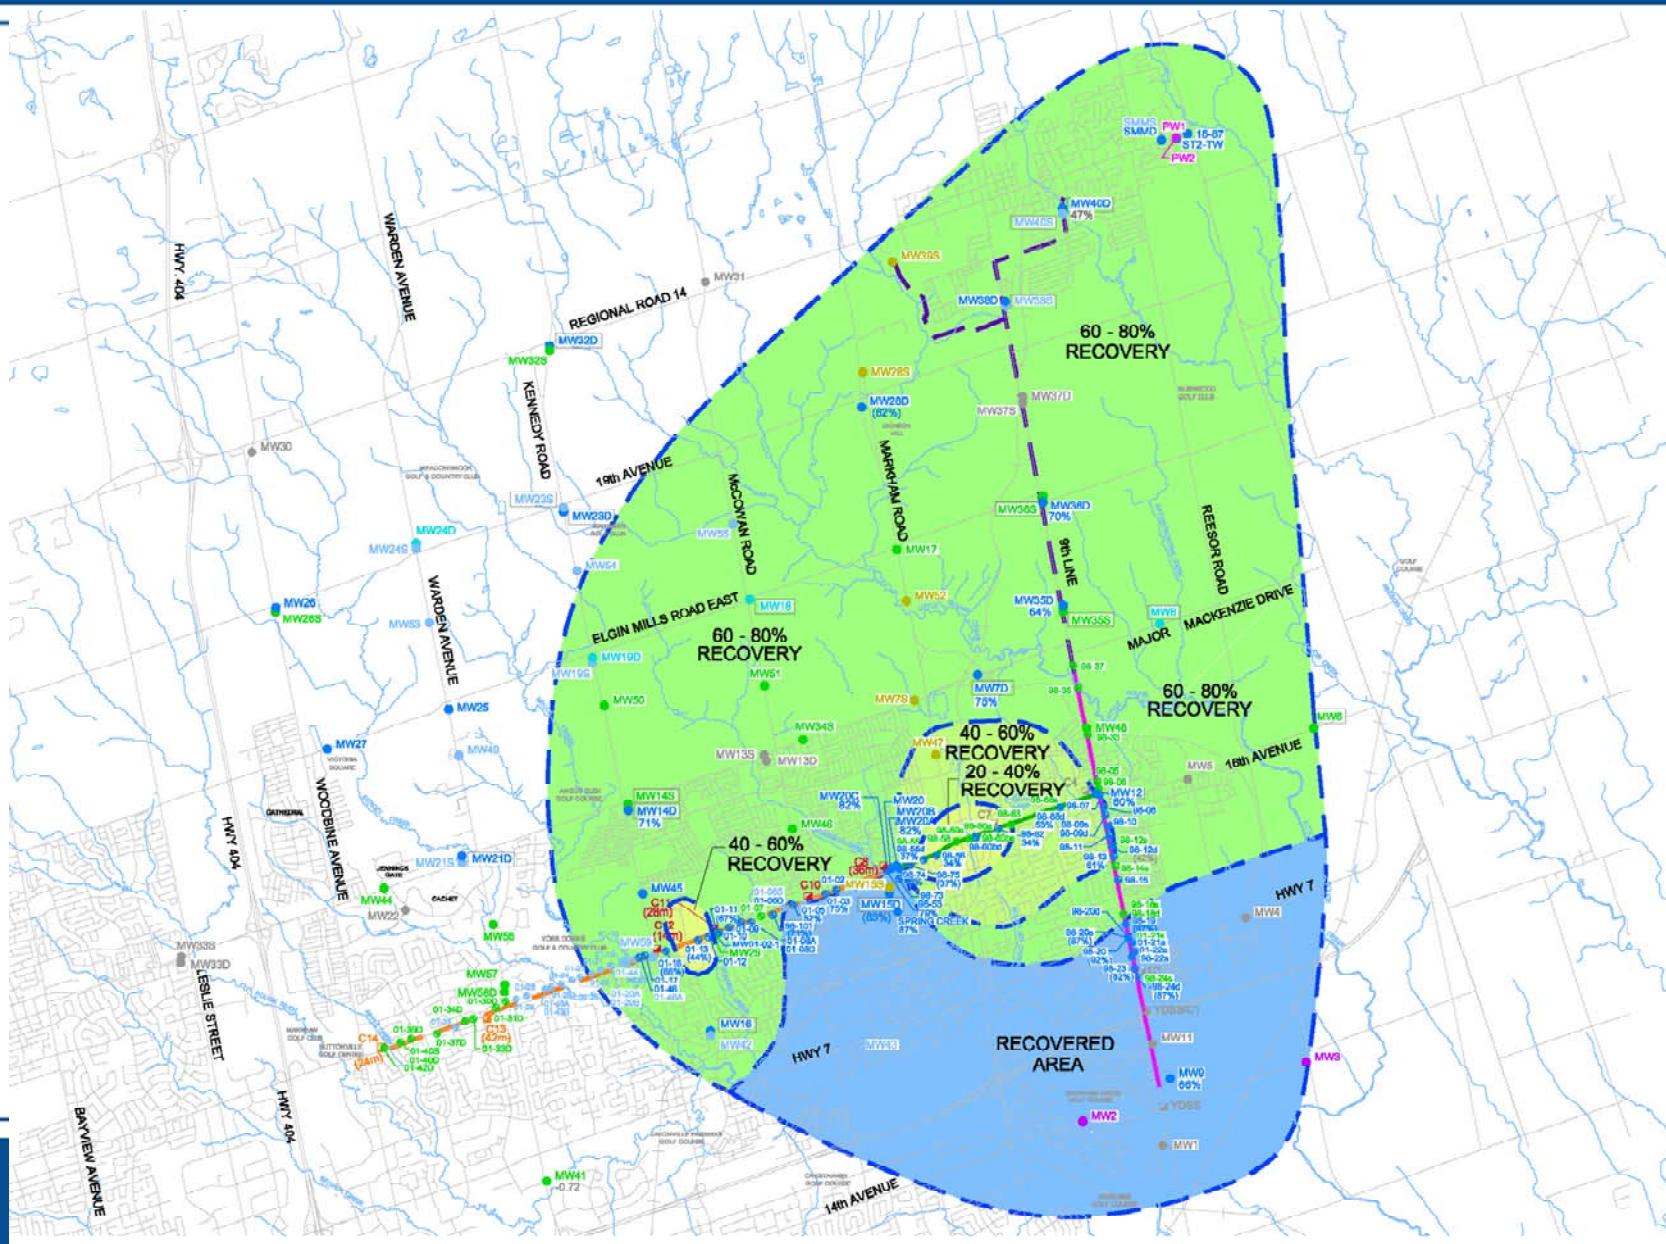
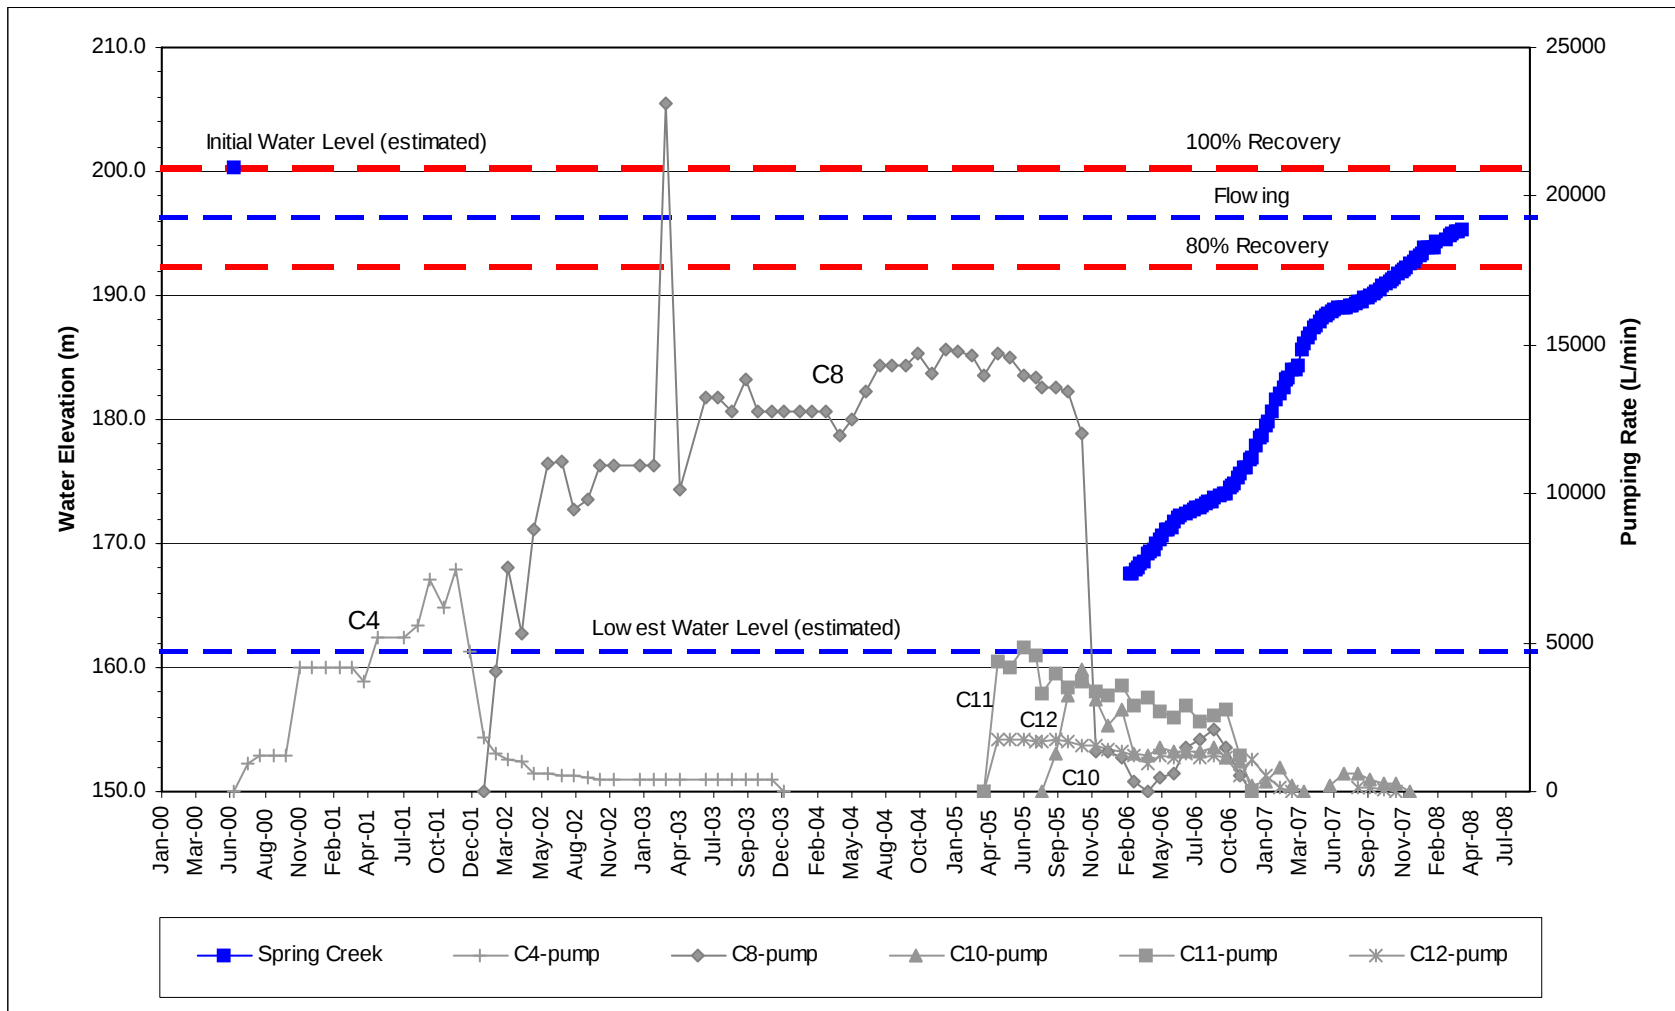
- Aquifer has been recovering more quickly than expected.
- Full recovery is likely to occur by the end of the year.
- Spring Creek should begin to flow again in May.
