## TOWN OF GEORGINA

RE: UTILITY POLES IN THE MIDDLE OF THE WALKWAY ALONG THE  
QUEENSWAY.

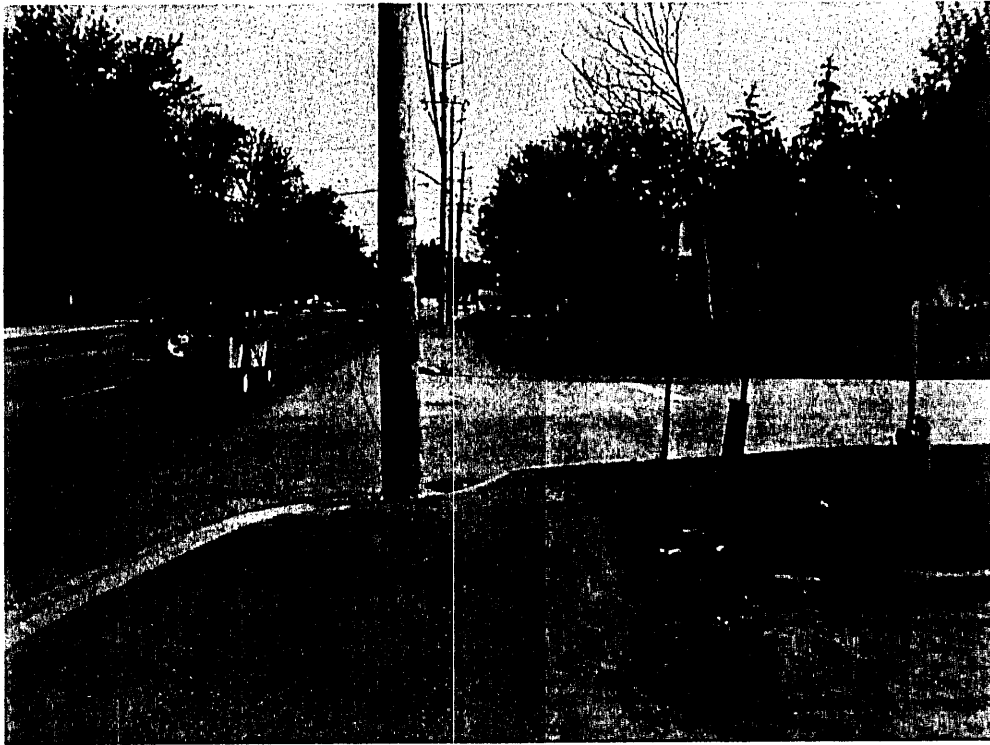
Mr. Mark Graff was witness to a gentleman using a motorized mobility device who could not manoeuvre around the hydro pole and ended up tipping over onto the roadway at Springwater. The gentleman was not injured, but the severity of the hazard needs to be addressed.

Picture #1: The Queensway looking north at Springwater. The telephone pole that is of concern is right in the middle of the curb cut, causing pedestrians with mobility devices to get one wheel up on the curb and tipping them over.

Conclusion: Obstructions such as telephone poles, benches, fire hydrants, etc. should be relocated or the walkway relocated so that the walkway has a free path of 1.8 metres or 6 feet minimum.

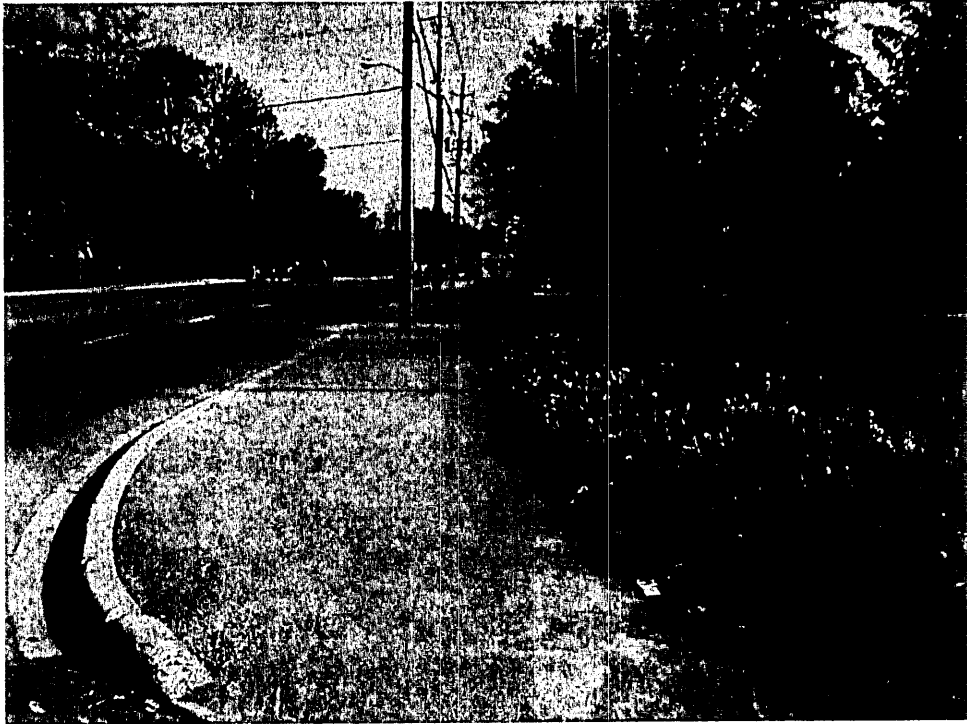
Picture #5: Looking further north on The Queensway at Springwater. Telephone poles exist right in the middle of the walkway.

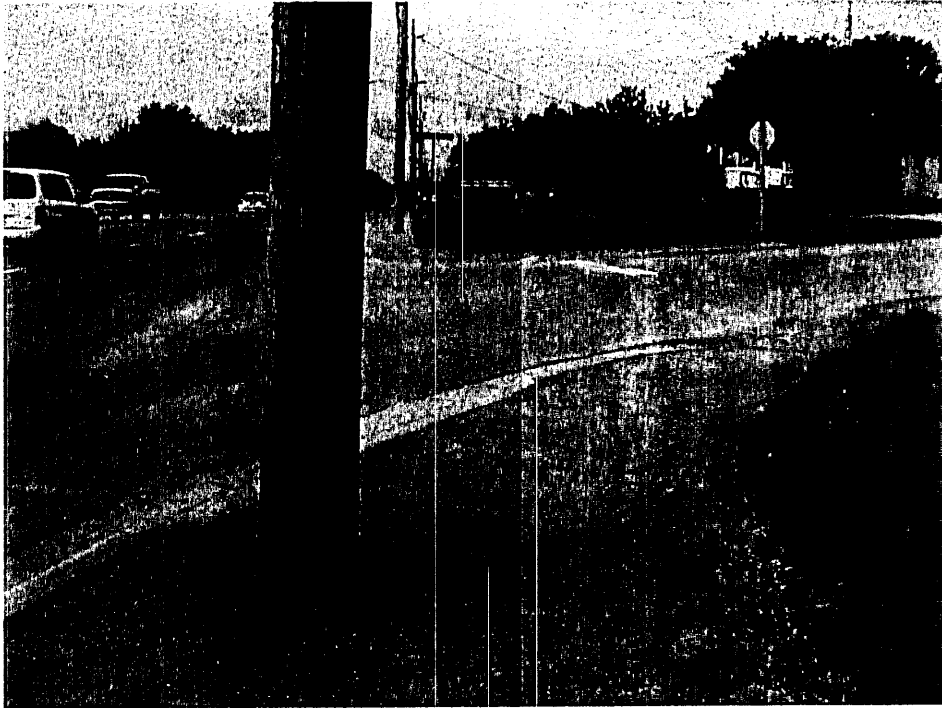
Picture #7: Looking South on The Queensway at Elmview Ave. This telephone pole is not as restrictive as the one found at Springwater but still difficult to manoeuvre around especially at a curb cut at a road crossing.
