**Re: Draft Regional Official Plan**  
**The Mandarin Golf and Country Club Inc. [Mandarin] (pts of Lots 28 and 29, Conc. 6, Markham), AV Investments II Inc. [AV] (Pt of Lt. 28, Conc. 6, Markham)**

**Re: Town of Markham Environmental Policy Review (EPR) Letter  
for McCowan Road Landowners**

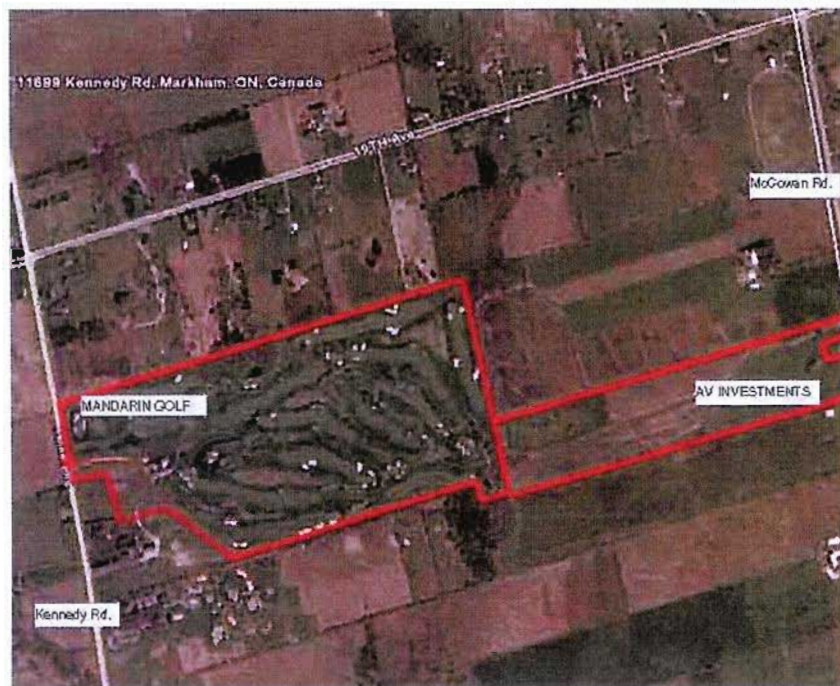
This submission is addressed to you on behalf of my clients, The Mandarin Golf and Country Club Inc. ('Mandarin') and AV Investments II Inc. ('AV'), the owners of the lands described above and illustrated in the following aerial photo:

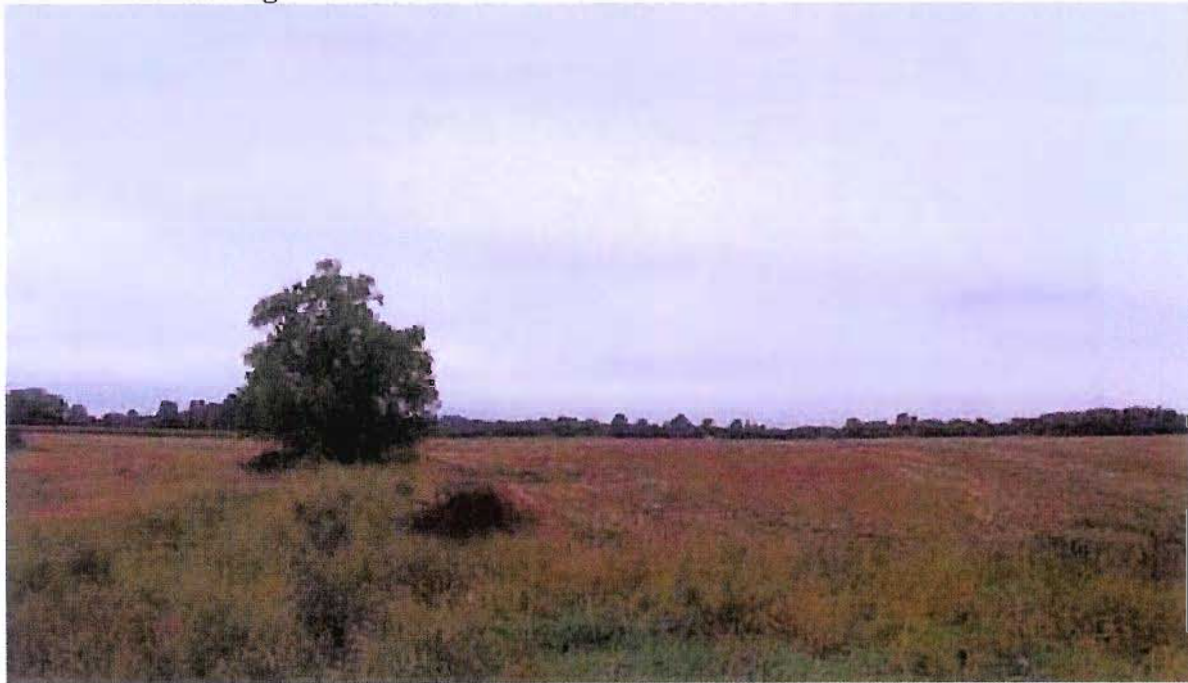
**View looking west from McCowan Road**

The Mandarin lands are carved, vegetated, groomed, and maintained for their long-standing purpose as an internationally recognized championship golf course. The AV lands are 100 % devoted to agriculture (cultivation). The photo below demonstrates the featureless nature of the AV lands.

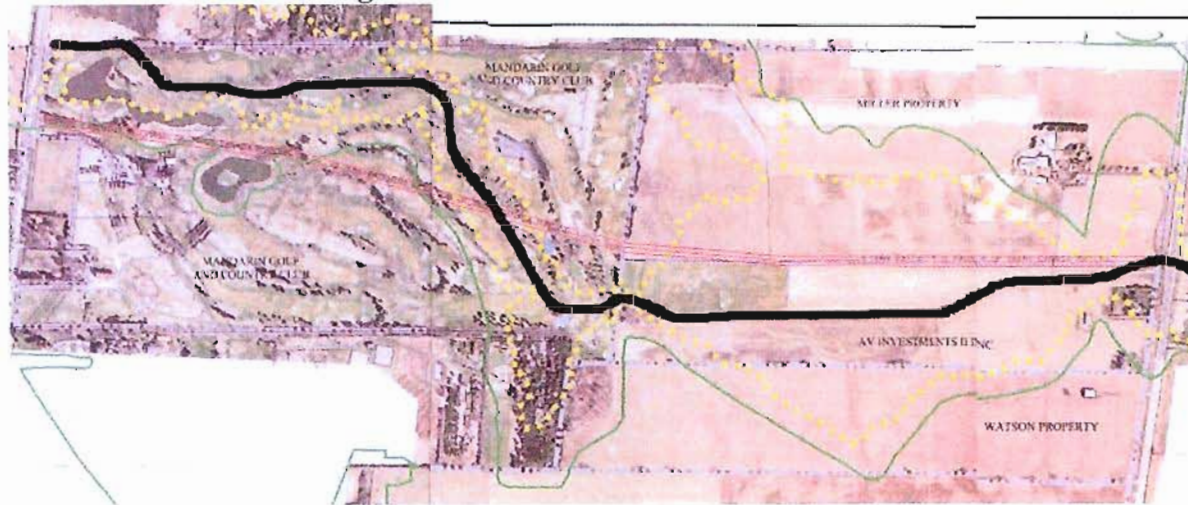
**Line of man-made drainage ditch**

The Mandarin lands and the AV lands are both bisected by a drainage channel.

In the case of the AV lands, the channel was dug in the 1950's as part of a tile drainage system installed to improve the productivity of the lands for agricultural purposes. It continues today to serve the same function.

The channel on the Mandarin lands was originally created in the -'70's to early '80's as part of the then owners plan to change swampland to golf course use. It was modified in 1990 for the present course layout. This drainage channel is illustrated by the black line shown on the map below.

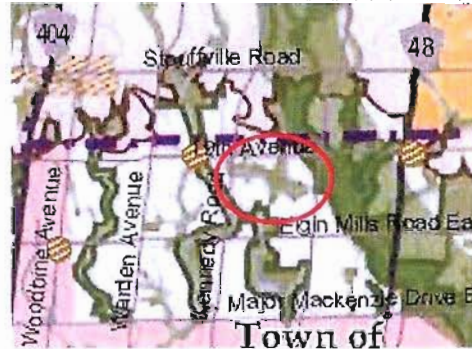
MAP EXCERPTS - PROPOSED ROP  
**MAP 2 REGIONAL GREENLANDS SYSTEM**

As shown below in the excerpts from the draft ROP (below) a massive portion of the Mandarin lands and virtually all of the AV lands are proposed to be designated 'Greenlands'. The drainage ditches are identified as 'Significant Natural Features'

(permanent and intermittent streams). This is so even though no environmentally sensitive areas or areas of natural or scientific interest are identified on the lands.
