**Re: 16<sup>th</sup> Avenue Trunk Sewer – Phase II  
Dewatering Complaint Review Committee - Follow-Up**

Reference No. T001374-26

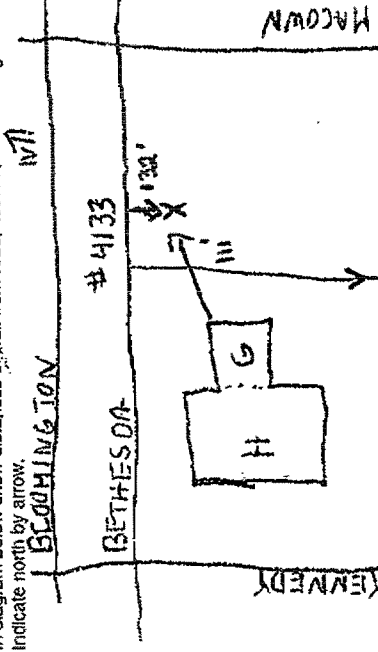
| Location of Well | |

| In diagram below show distances of well from road, lot line, and building.<br>Indicate north by arrow. | |
